L1358070001 – Montgomery
Eagle Zinc Company
ILD 930606941
SF/HRS

**CERCLA
EXPANDED SITE INSPECTION ADDENDUM REPORT**

Eagle Zinc Company

September 1, 2005

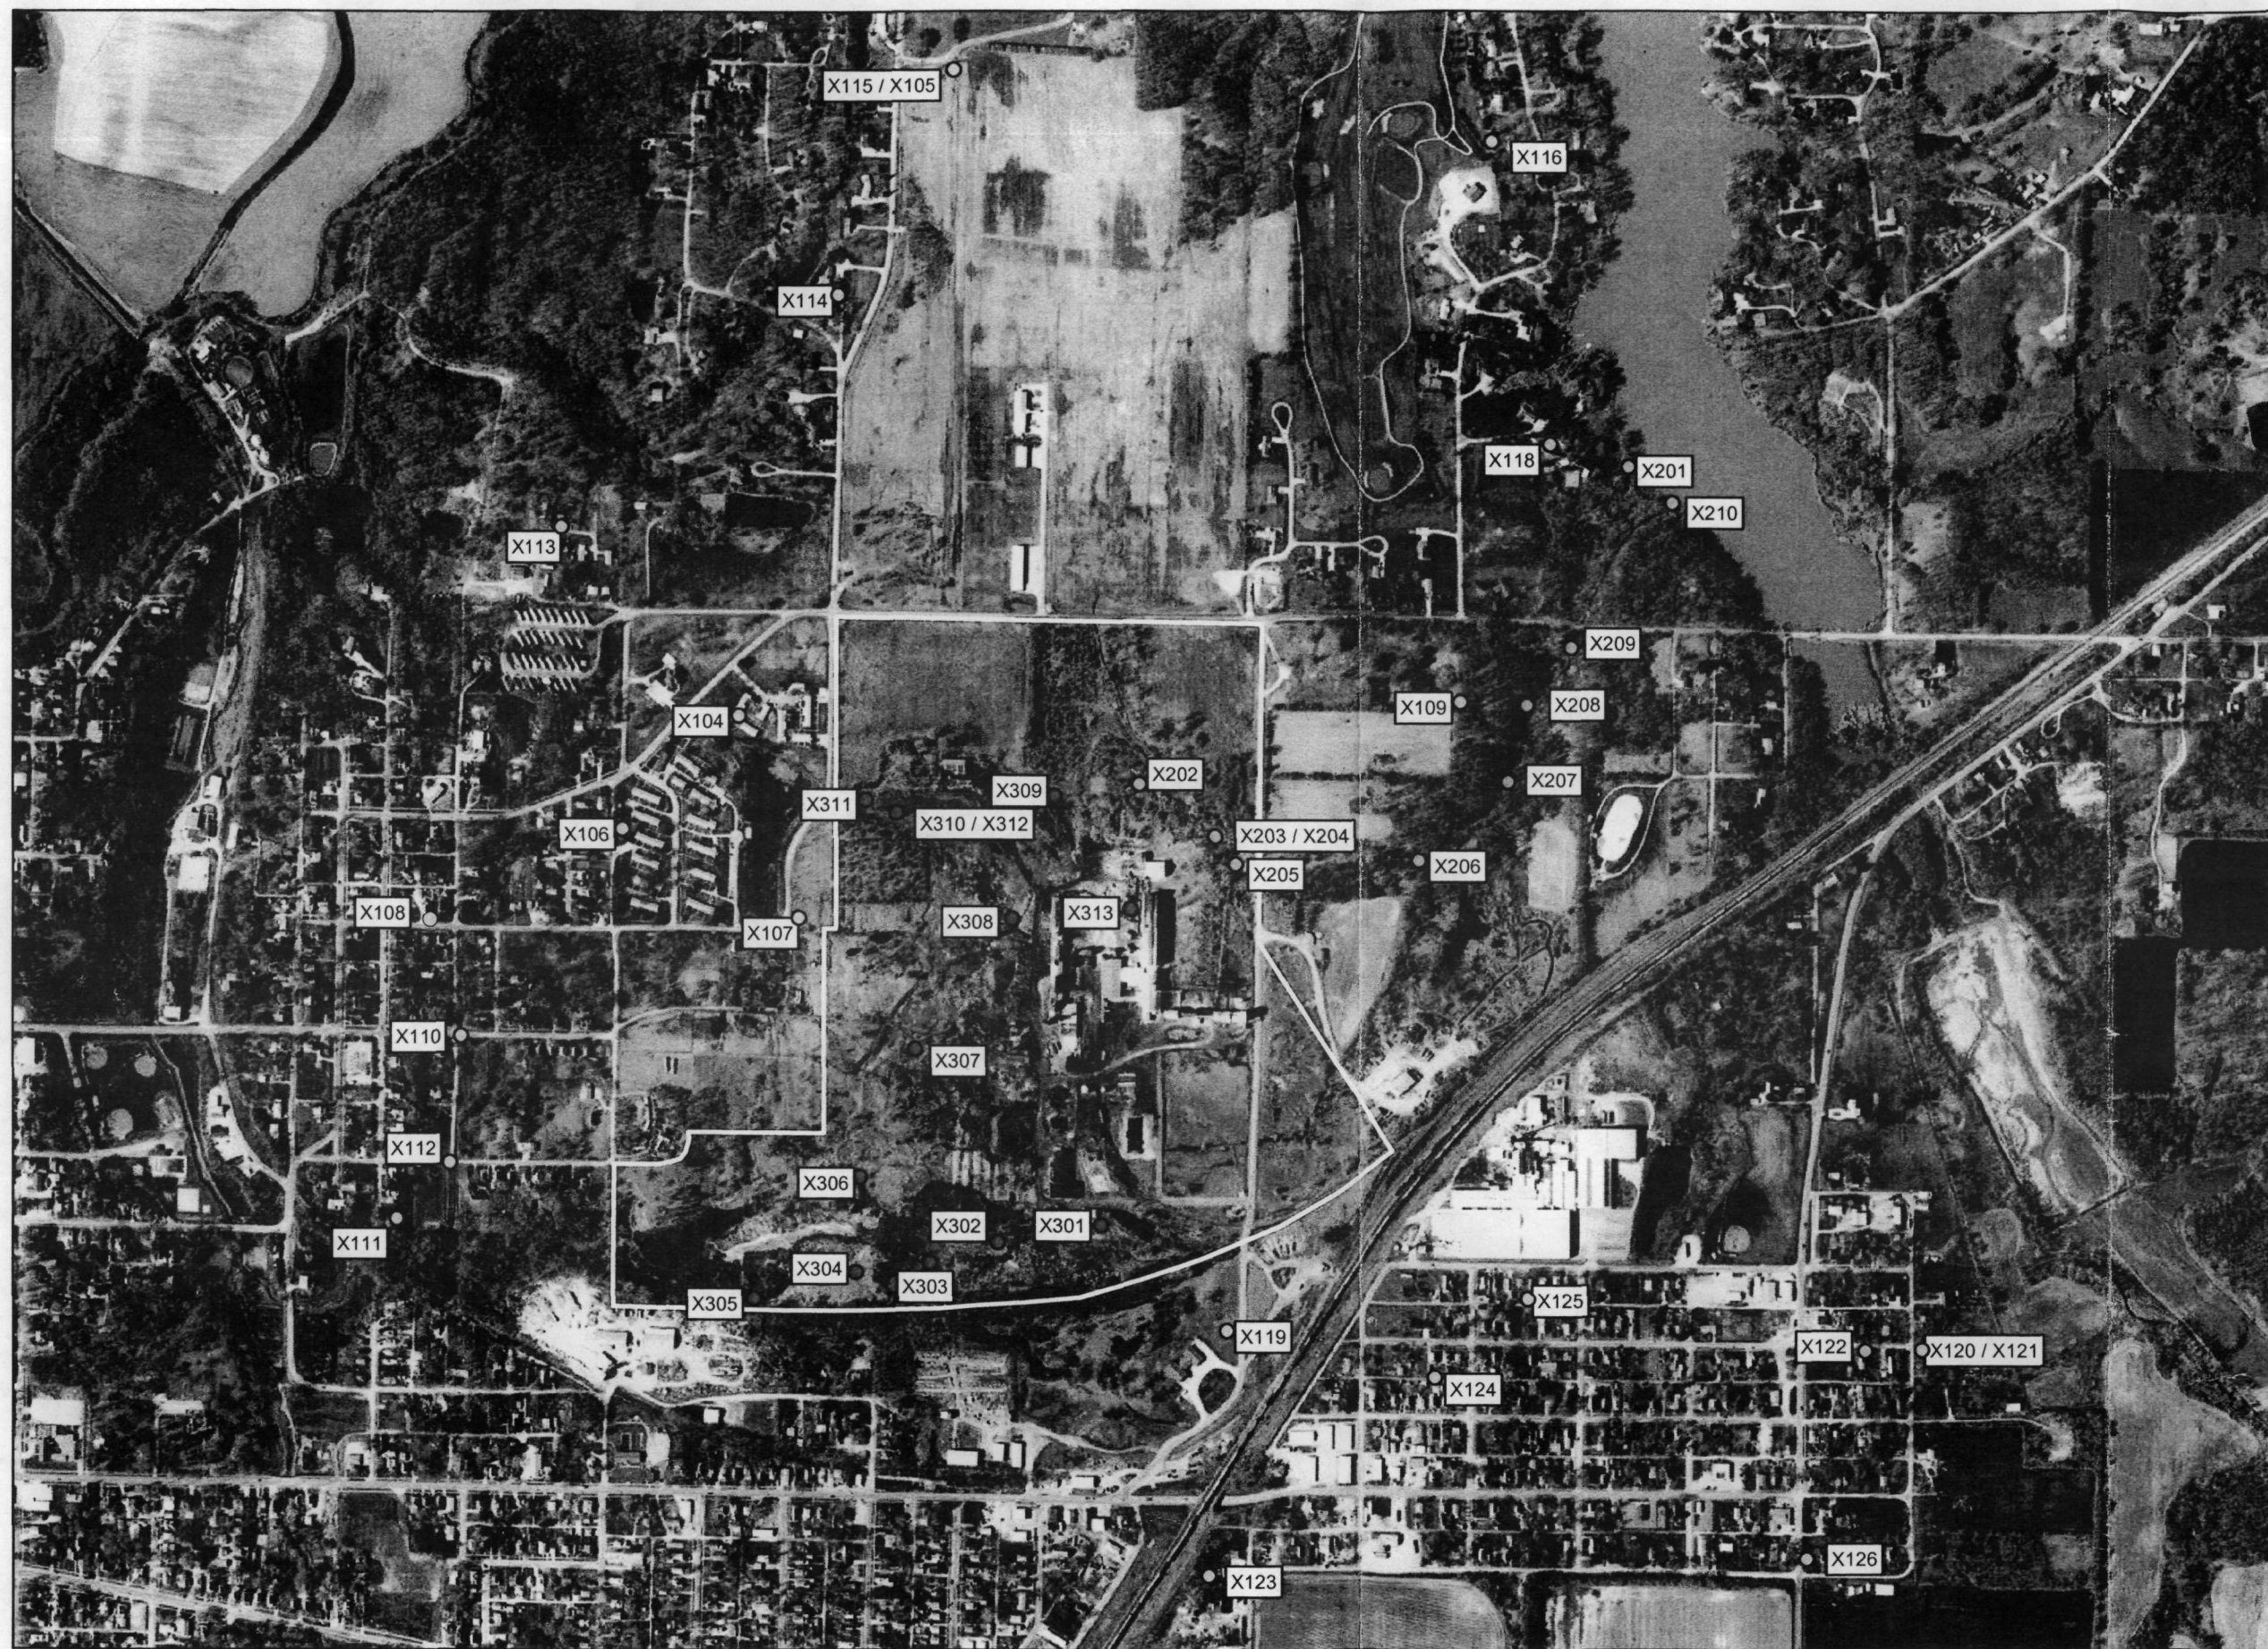
Figure 4
Eagle Zinc Company
Sample Location Map

Sample locations are shown in Figure 4 and described in Tables 1, 2 and 3. Key sample analytical results from the sampling events are shown in Tables 4, 5 and 6. XRF soil, sediment and waste results are shown in Tables 7, 8 and 9. The analytical results for the soil samples were compared to Removal Action Levels (RAL's).

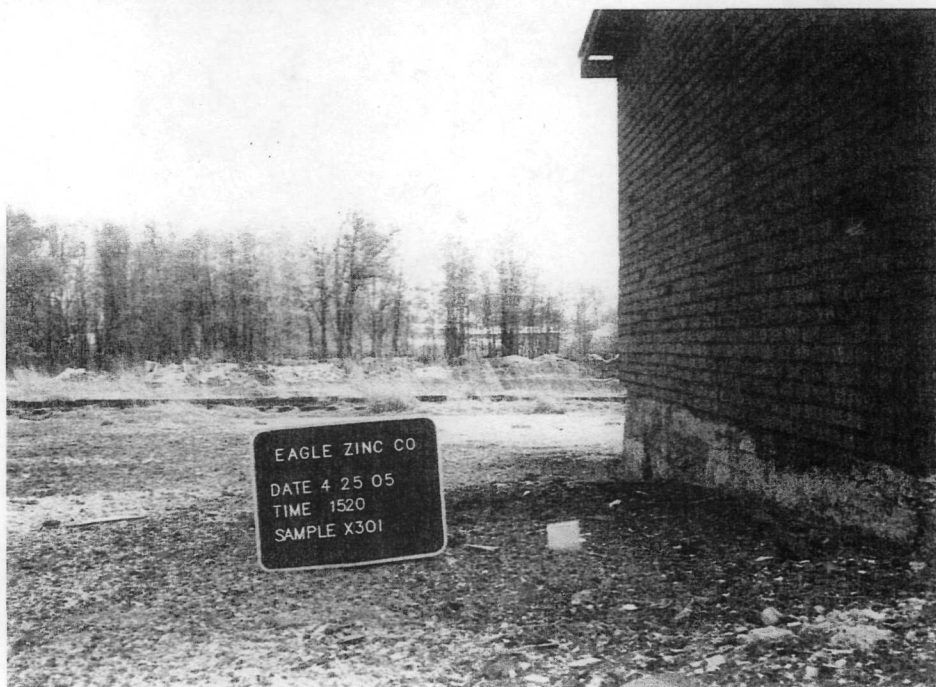
PHOTOGRAPH TAKEN BY: R. Casper
COMMENTS: Picture taken toward: South.
Photo Number 1.
Sample X301 was collected at the southeast area of the site from a black cinder pile.

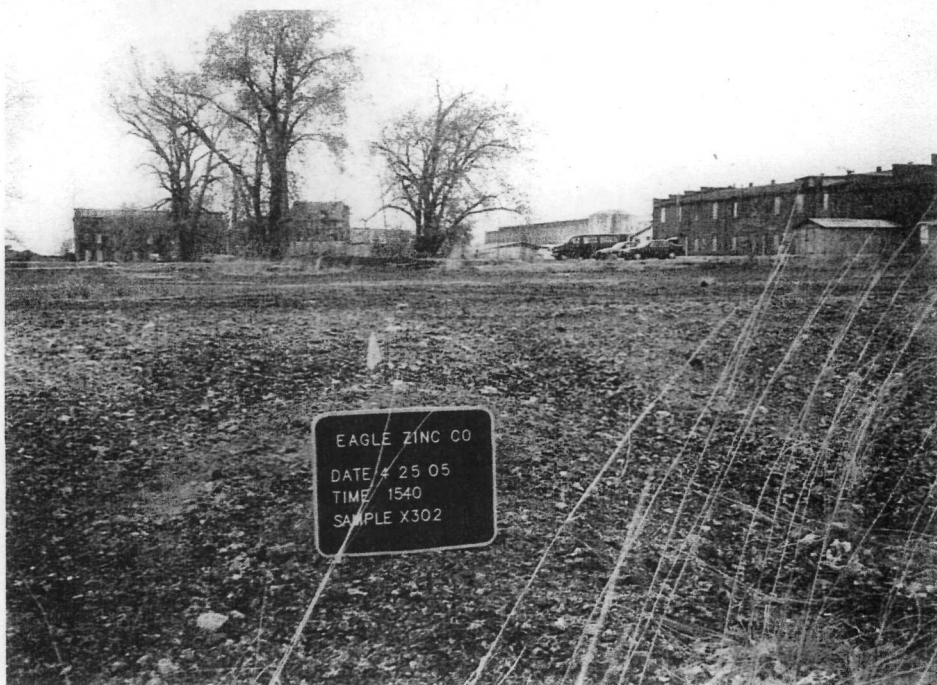
PHOTOGRAPH TAKEN BY: R. Casper
COMMENTS: Picture taken toward: North.
Photo Number 3.
Sample X302 was collected at the south area of the site from fine black cinders.

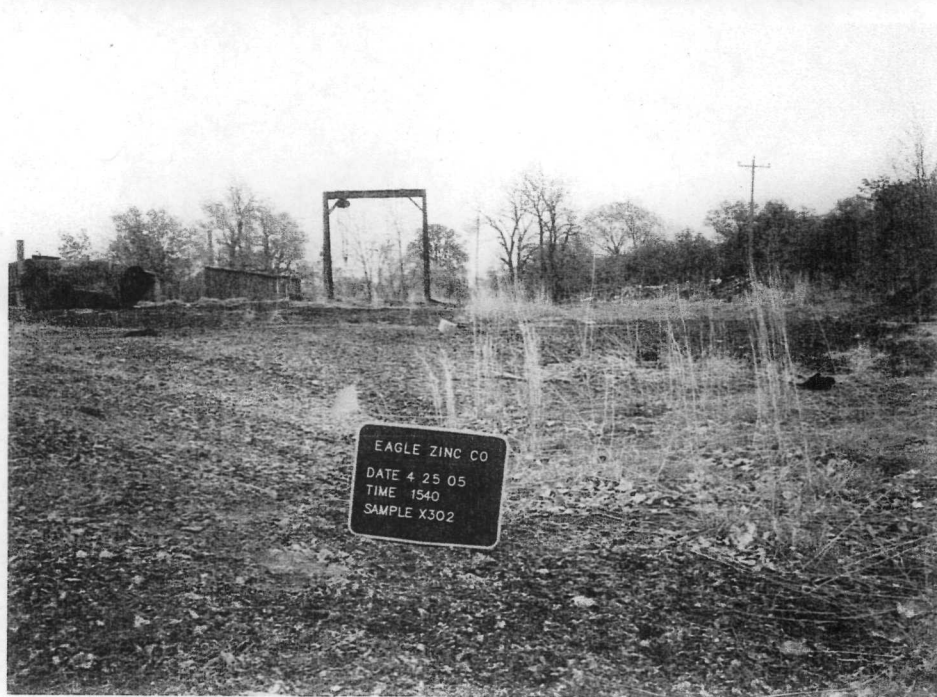
DATE: 4/25/05
TIME: 15:40
PHOTOGRAPH TAKEN BY: R. CASPER
COMMENTS: Picture taken toward: East.
Photo Number 4.
Sample X302. The area contains little vegetation. Collected at a depth of 0 to 2 inches.

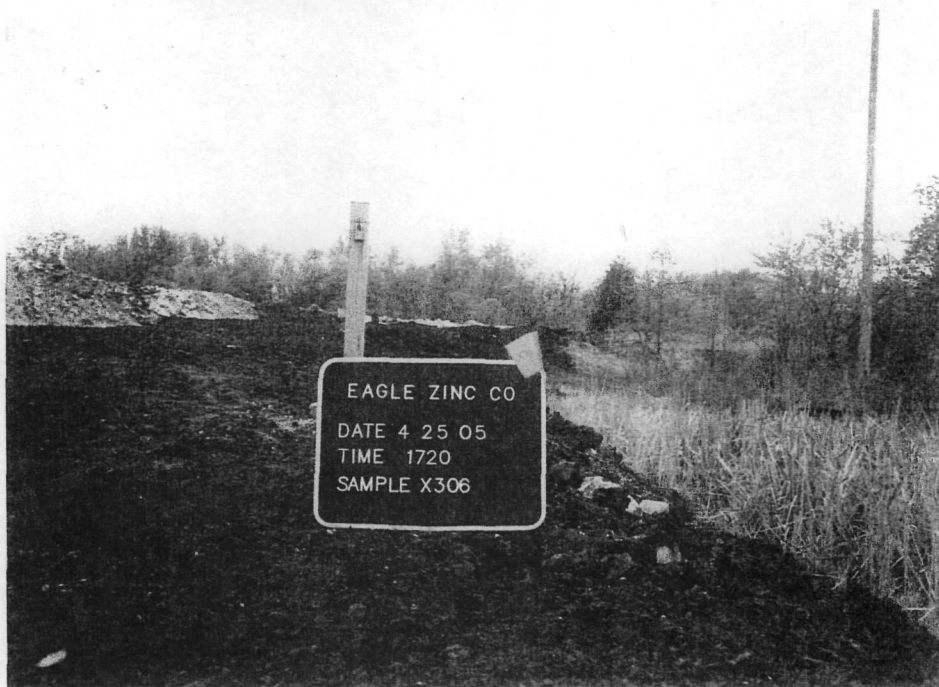
DATE: 4/25/05	SITE ILD#: 980606941	COUNTY: Montgomery
TIME: 17:20	SITE NAME: Eagle Zinc Co.	
PHOTOGRAPH TAKEN BY: R. Casper		
COMMENTS: Picture taken toward: South.		
Photo Number 11.		
Sample X306 was collected at the southwest area of the site from a slag & cinder pile.

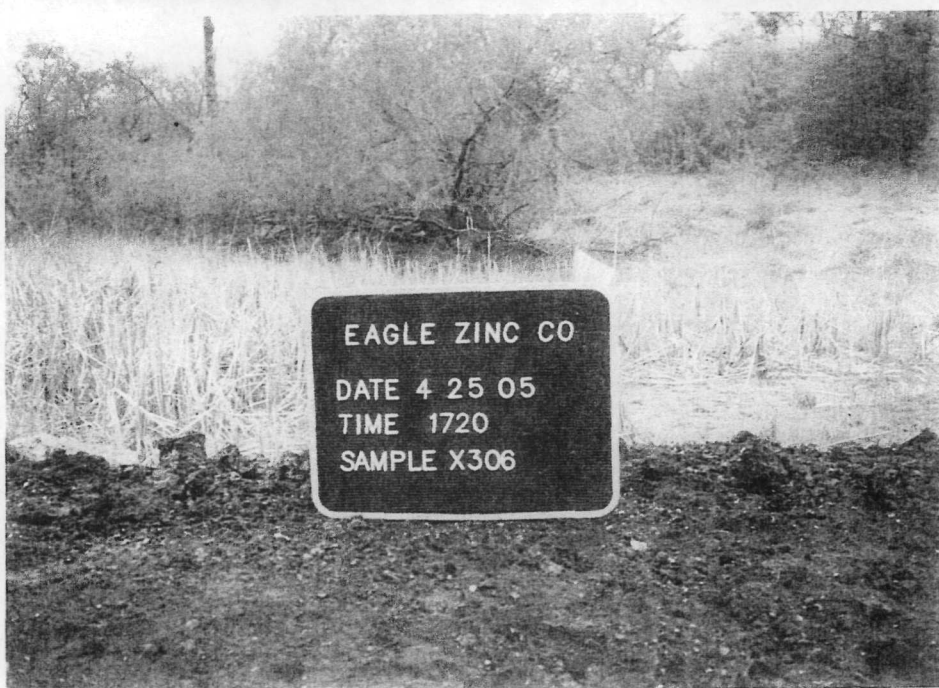
DATE: 4/25/05
TIME: 17:20
PHOTOGRAPH TAKEN BY: R. CASPER
COMMENTS: Picture taken toward: West.
Photo Number 12.
Sample X306. The sample consisted of a gray material collected at a depth of 0 to ½ inches.

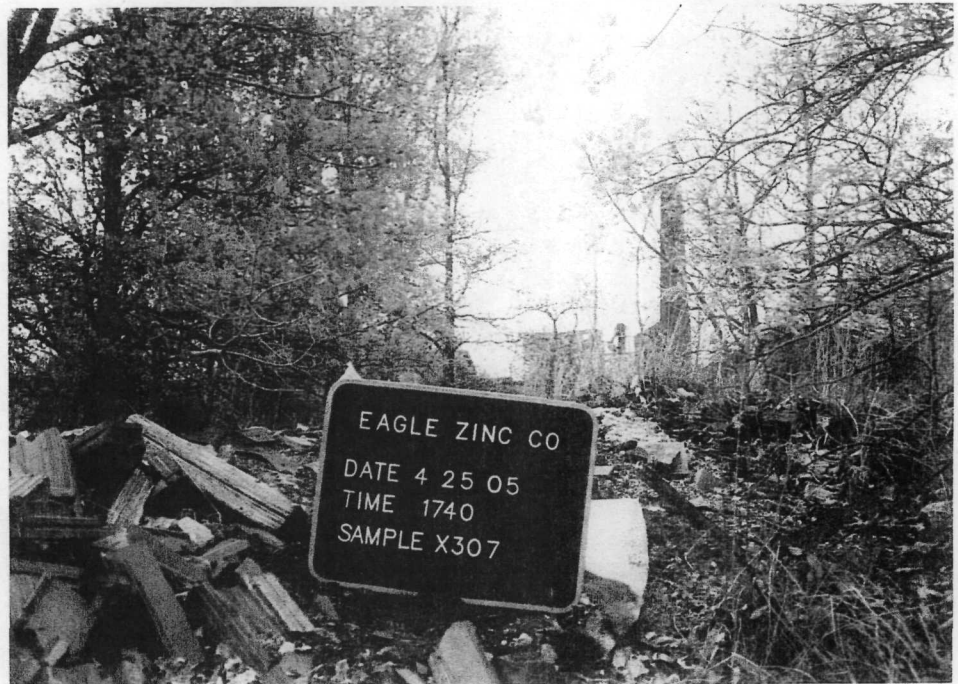
PHOTOGRAPH TAKEN BY: R. Casper
COMMENTS: Picture taken toward: East.
Photo Number 13.
Sample X307 was collected at the west central area of the site from a cinder/brick pile.

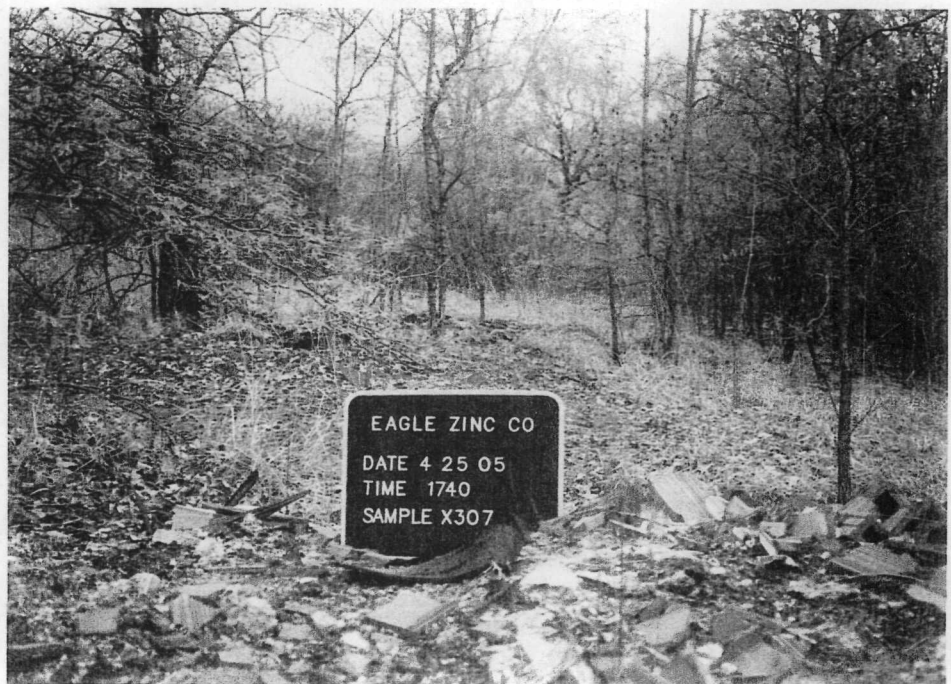
DATE: 4/25/05
TIME: 17:40
PHOTOGRAPH TAKEN BY: R. CASPER
COMMENTS: Picture taken toward: South.
Photo Number 14.
Sample X307. The sample consisted of a fine brown/ gray material col- lected at a depth 0 to ½ inches.

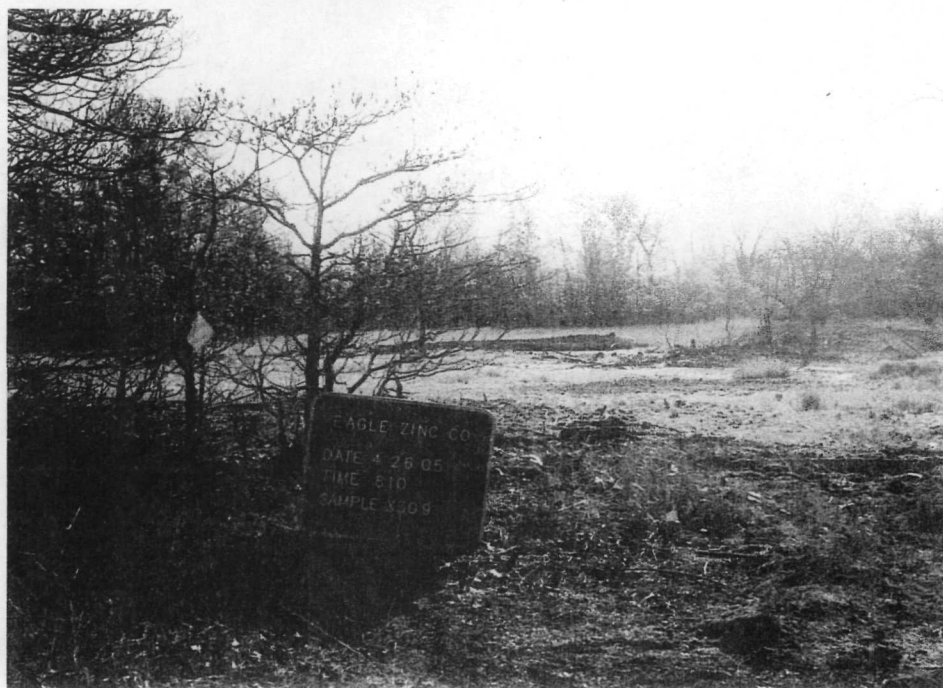
DATE: 4/26/05	SITE ILD#: 980606941	COUNTY: Montgomery
TIME: 8:10	SITE NAME: Eagle Zinc Co.	
PHOTOGRAPH TAKEN BY: R. Casper		
COMMENTS: Picture taken toward: East.		
Photo Number 17.		
Sample X309 was collected at the northwest area of the site from a slag pile.

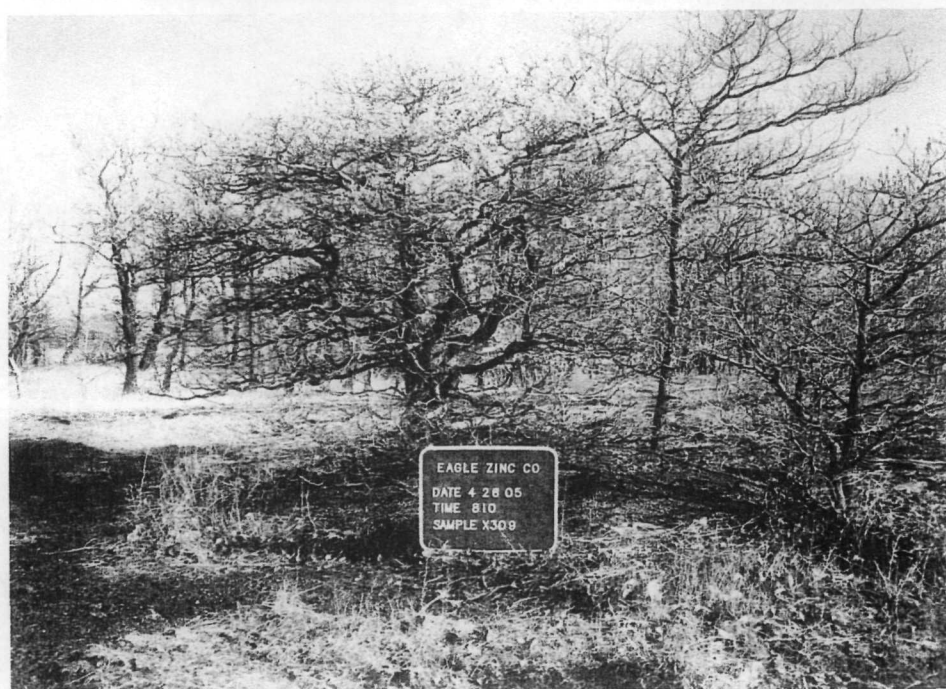
DATE: 4/26/05
TIME: 8:10
PHOTOGRAPH TAKEN BY: R. CASPER
COMMENTS: Picture taken toward: North.
Photo Number 18.
Sample X309. The sample consisted of a fine medium gray material with metal shavings, depth 0 to 1/2 inches

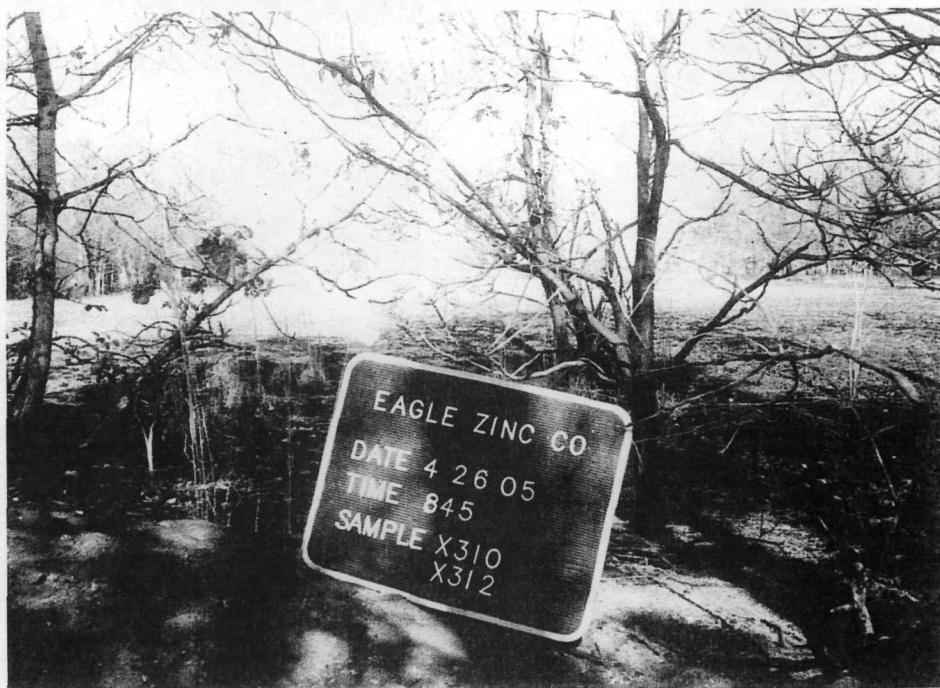
PHOTOGRAPH TAKEN BY: R. Casper
COMMENTS: Picture taken toward: West.
Photo Number 21.
duplicate samples
X310/X312 collected
at the northwest
area of the site.

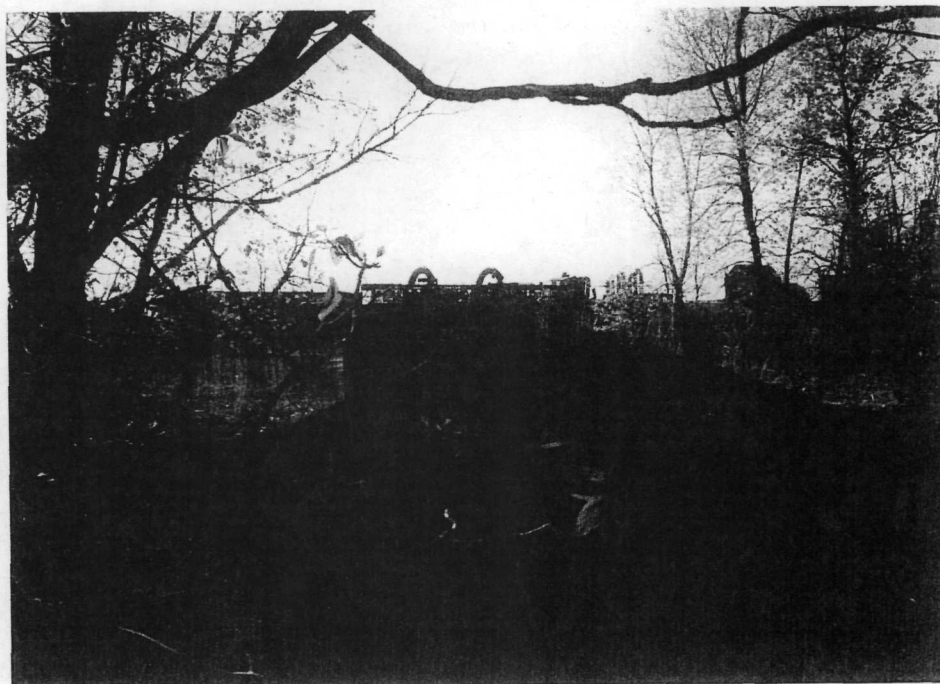
DATE: 4/26/05
TIME: 8:45
PHOTOGRAPH TAKEN BY: R. CASPER
COMMENTS: Picture taken toward: East.
Photo Number 22.
Samples X310/X312.
Sample consisted
of a fine medium
gray slag material.

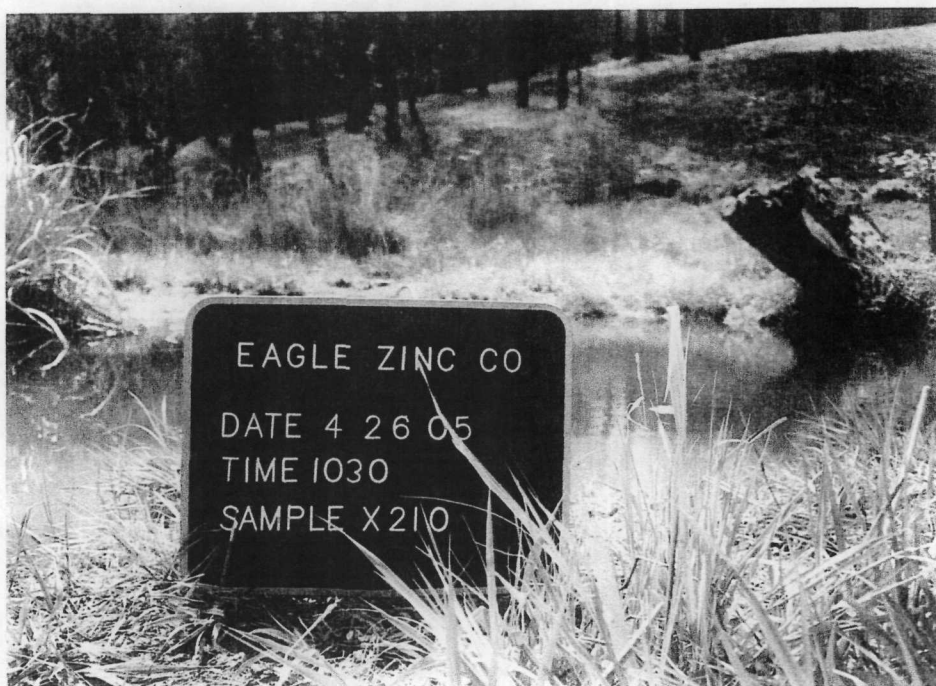
DATE: 4/26/05	SITE IL# #: 980606941	COUNTY: Montgomery
TIME: 10:30	SITE NAME: Eagle Zinc Co.	
PHOTOGRAPH TAKEN BY: R. Casper		
COMMENTS: Picture taken toward: East.		
Photo Number 25.		
Sample X210 was collected from a brownish-gray silty clay sediment at a depth of 3" to 5".

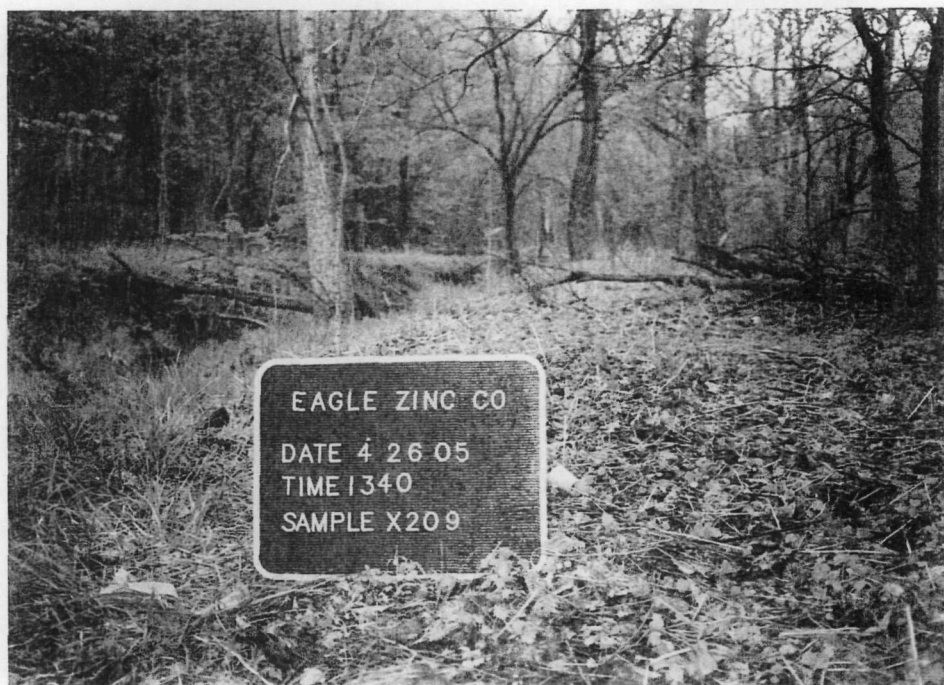
PHOTOGRAPH TAKEN BY: R. Casper
COMMENTS: Picture taken toward: South.
Photo Number 29.
Sample X209 was collected south of Smith road, in the offsite drainage pathway.

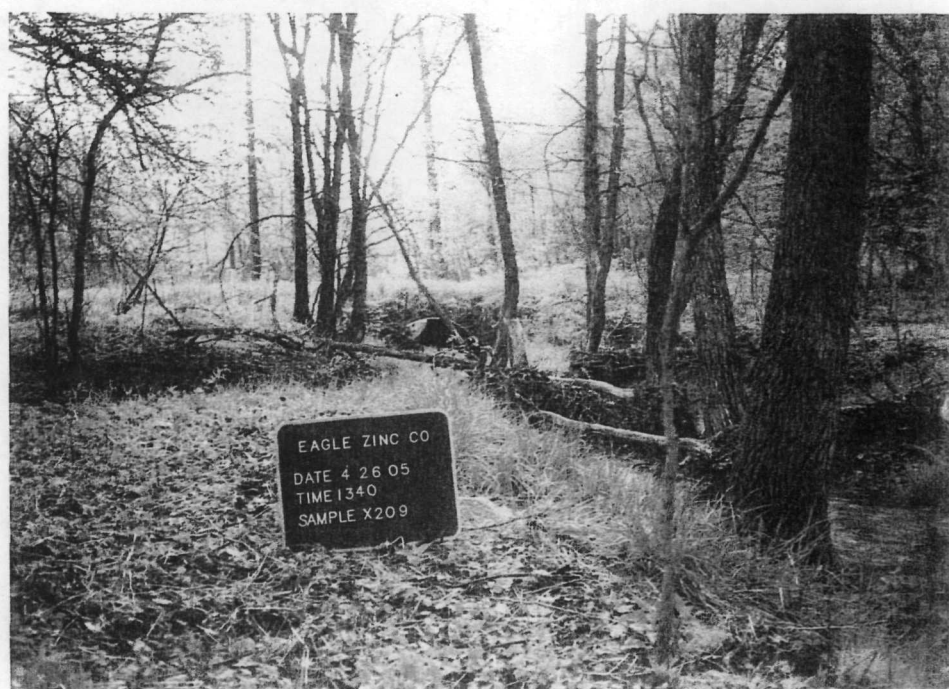
DATE: 4/26/05
TIME: 13:40
PHOTOGRAPH TAKEN BY: R. CASPER
COMMENTS: Picture taken toward: North.
Photo Number 30.
Sample X209. The sample consisted of a brown sandy clay with some silt and organic material.

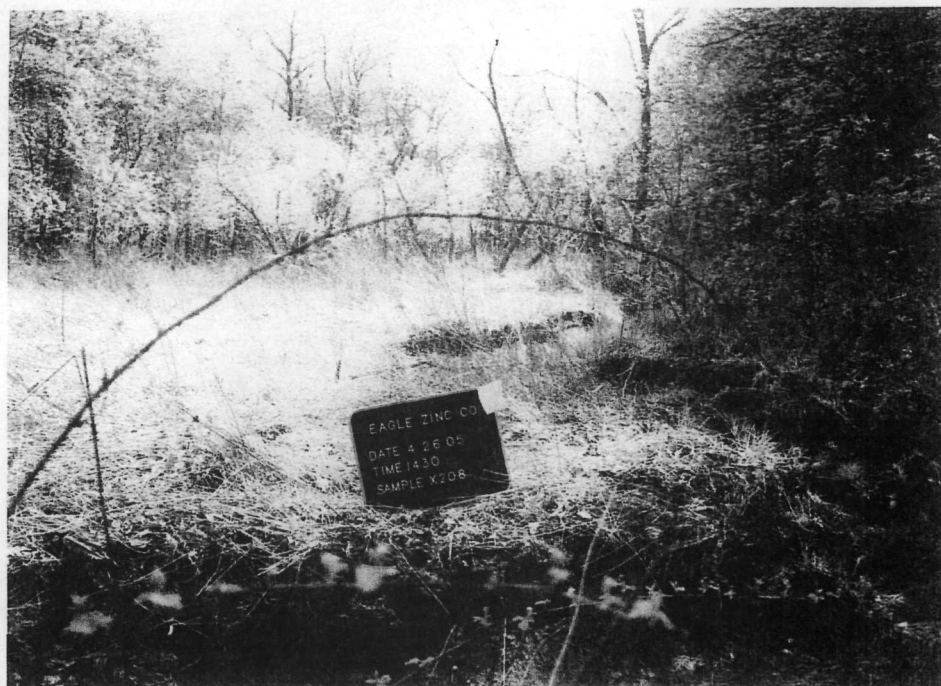
PHOTOGRAPH TAKEN BY: R. Casper
COMMENTS: Picture taken toward: South.
Photo Number 31.
Sample X208 was collected in the offsite drainage pathway south of Smith Road.

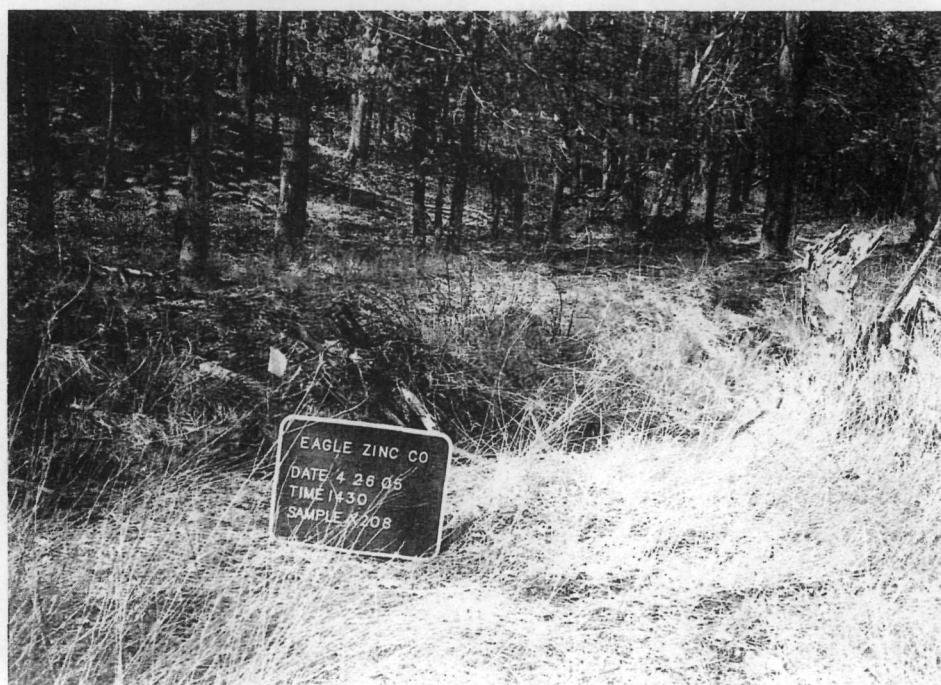
DATE: 4/26/05
TIME: 14:30
PHOTOGRAPH TAKEN BY: R. CASPER
COMMENTS: Picture taken toward: North.
Photo Number 32.
Sample X208. The sample consisted of a brown silt. Collected at a depth of 0 to 2 inches.

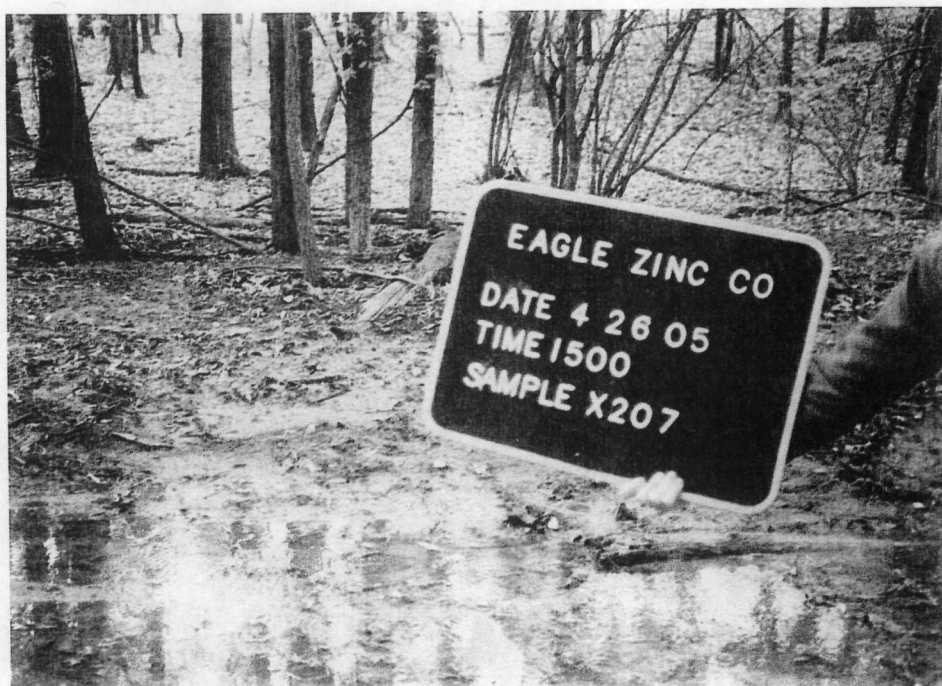
PHOTOGRAPH TAKEN BY: R. Casper
COMMENTS: Picture taken toward: West.
Photo Number 33.
Sample X207 was collected from the drainage pathway southeast of the site.

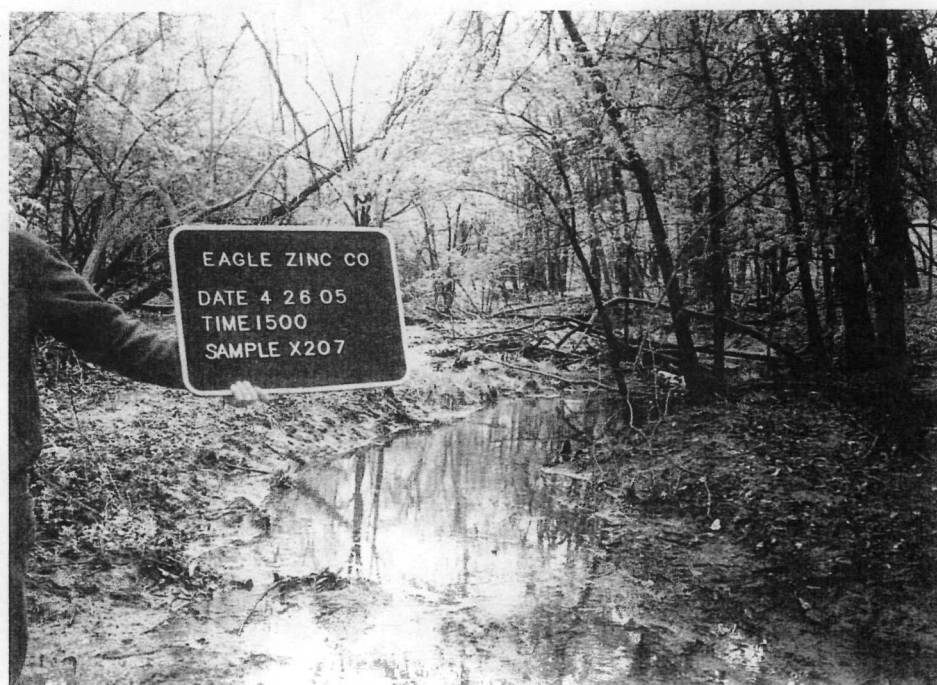
DATE: 4/26/05
TIME: 15:00
PHOTOGRAPH TAKEN BY: R. CASPER
COMMENTS: Picture taken toward: South.
Photo Number 34.
Sample X207. The sample consisted of a brown silt with a little sand and clay.

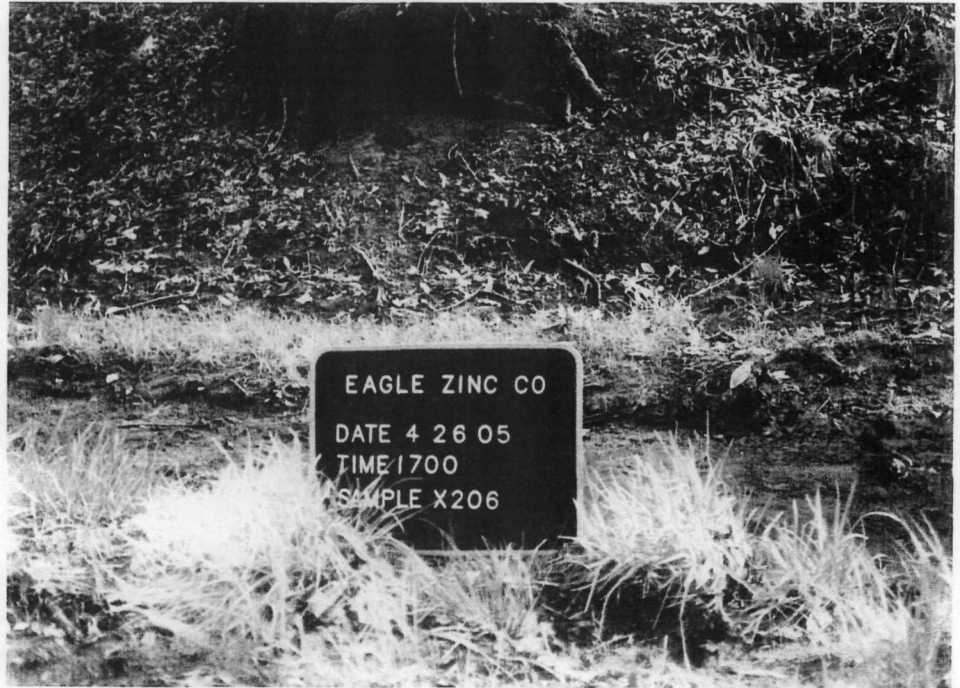
DATE: 4/26/05	SITE ILD#: 980606941	COUNTY: Montgomery
TIME: 17:00	SITE NAME: Eagle Zinc Co.	
PHOTOGRAPH TAKEN BY: R. Casper		
COMMENTS: Picture taken toward: South.		
Photo Number 35.		
Sample X206 was collected offsite east of Industrial Park Road.

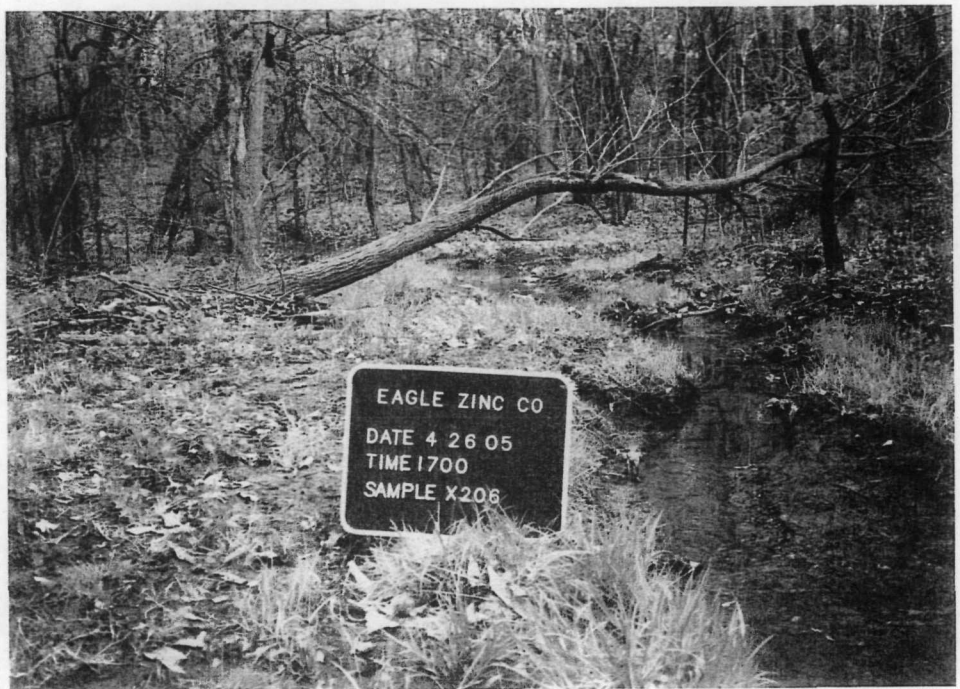
DATE: 4/26/05
TIME: 17:00
PHOTOGRAPH TAKEN BY: R. CASPER
COMMENTS: Picture taken toward: East.
Photo Number 36.
Sample X206. The sample consisted of a brown silty clay, collected at a depth of 3 to 5 inches.

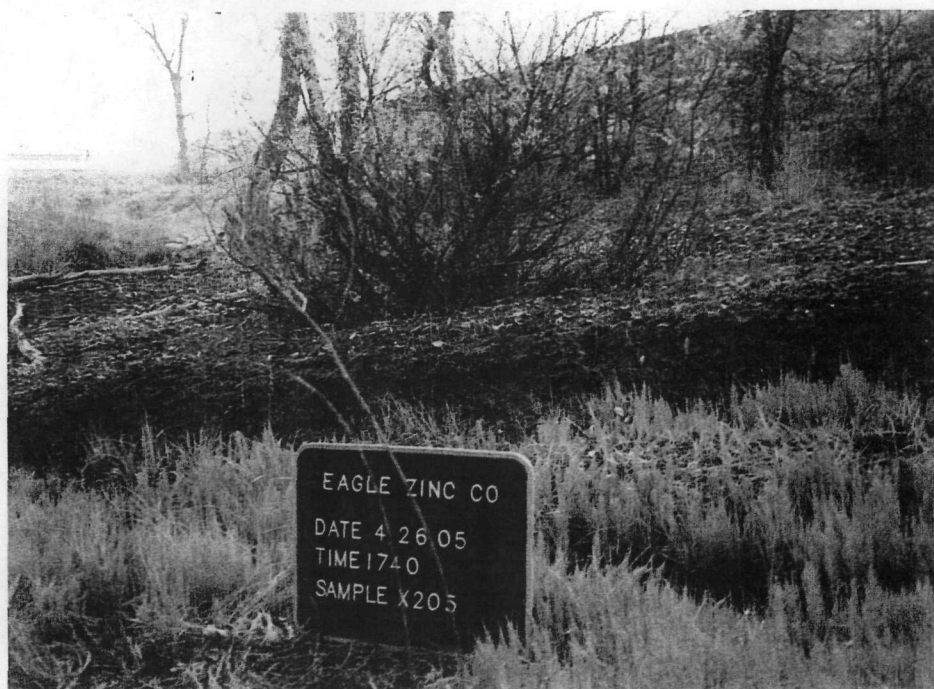
PHOTOGRAPH TAKEN BY: R. Casper
COMMENTS: Picture taken toward: South.
Photo Number 37.
Sample X205 was collected onsite approximately 75 feet west of Indus- trial Park Road.

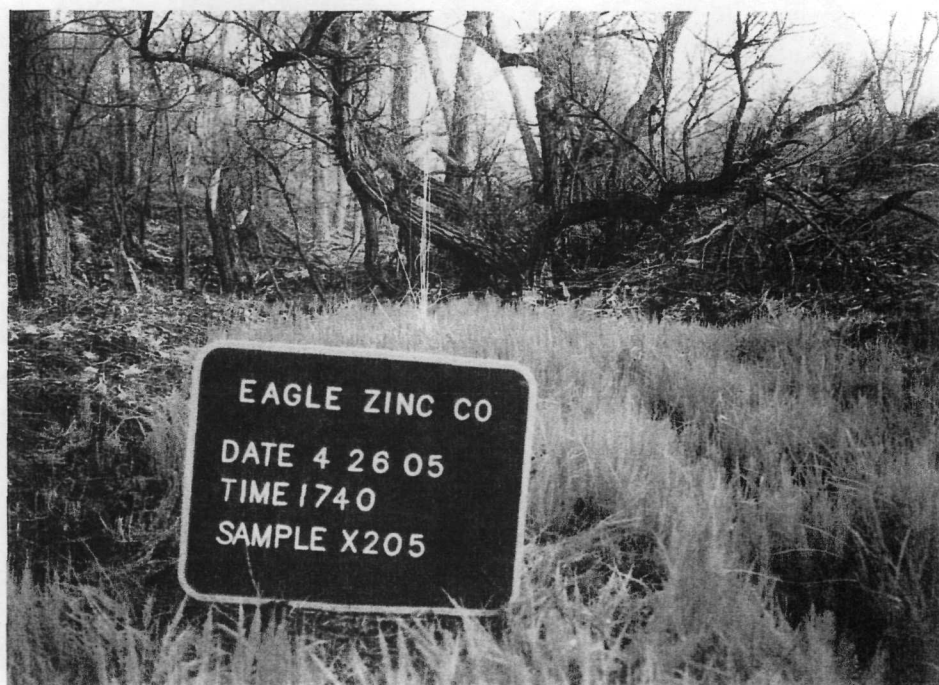
DATE: 4/26/05
TIME: 17:40
PHOTOGRAPH TAKEN BY: R. CASPER
COMMENTS: Picture taken toward: East.
Photo Number 38.
Sample X205. The sample consisted of a brown silty clay collected from 0 to ½ inches.

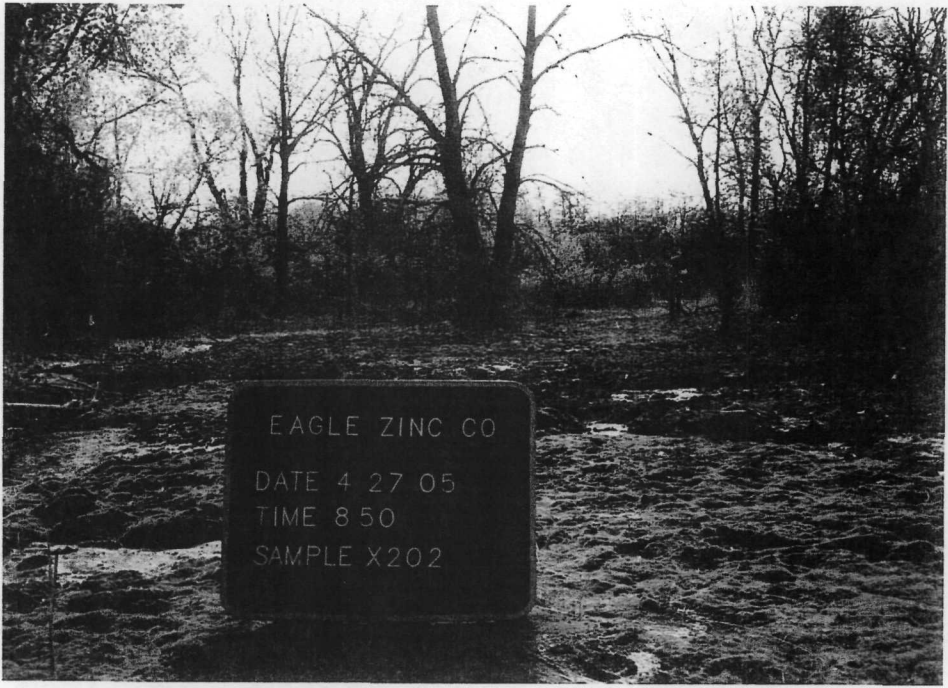
COMMENTS: Picture taken toward: East.		
Photo Number 41.		
Sample X202 was collected in the onsite drainage pathway.
